***shelter***

## 1 SAMPLE STREET

#### ADVICE SOUGHT: Provide Expert Witness report for QCAT Hearing

Carry out additional inspections and offer independent advice regarding itemised defects as noted in Z\*#@ Constructions and BSA reports of construction work of additions to dwelling at 1 Sample Street. Construction by Sample Constructions PTY LTD.

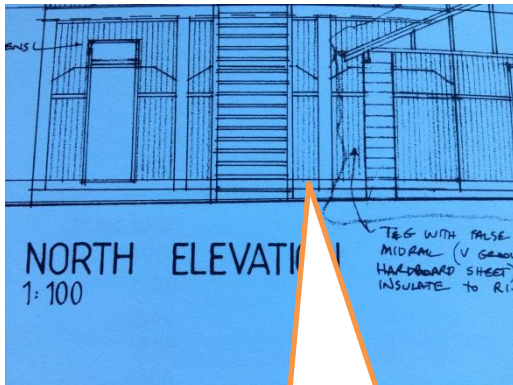
- The documentation notes the base tread being generally at the same level as the Carport and as noted z\*#@ photo 1 and;
- Height difference from driveway to ground level suggesting awaiting 'finished ground levels' from graded fill.

Note 'indicative' finished height match of step to slab.

**Recommendation:** Owner to fill to suitable 'finished ground levels' to comply with BCA and make frontage area including fill to driveway edge foot traffic useable.

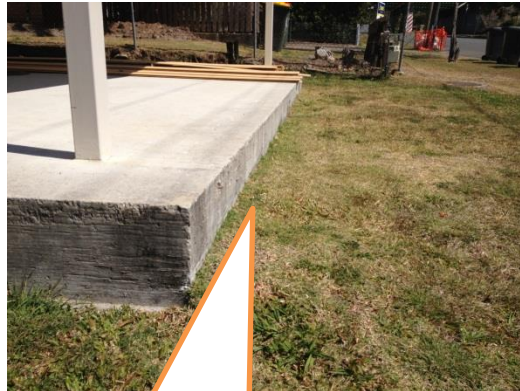
Safety issue due to height to frontage supporting proposed future fill.

**Deemed:** Incomplete works.

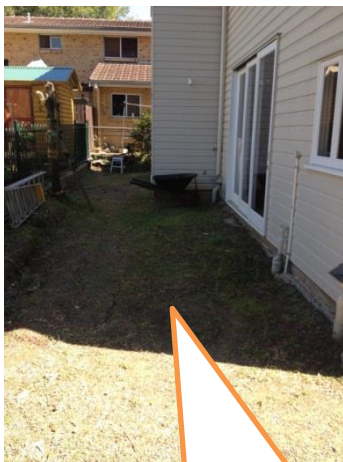
The following photos note that falls to the building perimeter generally discharge surface water away from perimeter as the BCA intention. Note: It was also stated by Builder that boundary retaining wall/fencing was to be installed which would enable excavation works, final trim and hard surfacing to be carried out concurrently.

Surface water generally falls to boundary.

**Deemed:** NO DEFECT & “Alternative (Performance) Solution” at present, awaiting final desired surface finish.

**Recommendation:** Owner to finish intended paving landscaping to areas. The large access door indicates hard surface treatment is expected to occupy the area. Note: Refer 4.2 Z\*#@ conclusion BCA Part 3.2.2.1 refer to Excavation for footings is NA.

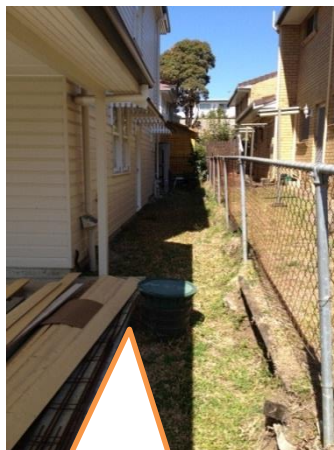
Surface water generally falls to frontage

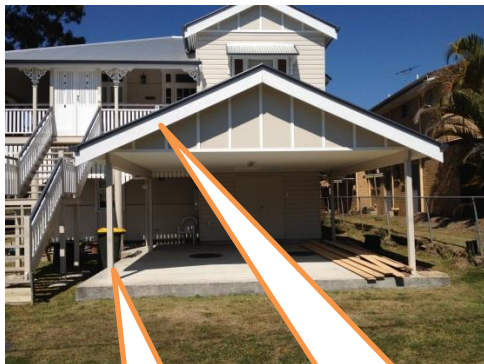
Garage is 200mm shorter in width (bracing panels also omitted). The modification has enabled the rear to mate with the house without impact. Omission of bracing panels is considered a having irrelevant structural impact with reference to AS 1170,4100,3700. The modifications to gain the extra 200mm opening to 5800mm as documented with have a substantial 'appearance' impact on the structure as it will require:

Posts relocated  
off centre of  
slab concrete.

**Deemed:** A 'no impact non-compliance with documentation'. As it has neither an appearance or operational impact, or a not 'fit or purpose' defect, therefore it is not considered a defect.

**Recommendation:** Pursuing any 'rectification' action will be detrimental to the finished appearance of the building as the work 'as is' has no 'operational' impact to rectify. Engineering is considered not required to confirm structural adequacy for deletion of bracing walls due to method of post fixing, lateral movement roof bracing and existing house as bracing walls.

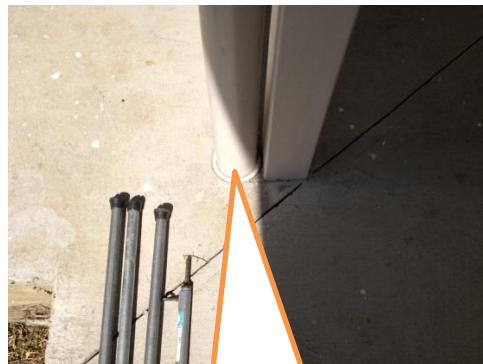
Roof would have variable  
size members

New downpipe location will be  
unsuitable.

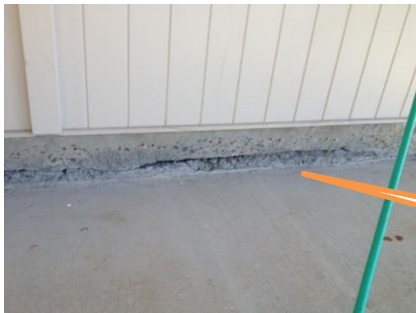
**REVIEWED 17 9 12** The cutting of existing slab exposed inadequate depth of concrete in areas causing exposed unsightly areas. New slab has spot proud concrete slurry to edges of existing slab to 2 corners. The finished Concrete patio apron slab was noted by Builder as to have tiled finish, recommended to horizontal and vertical surfaces.

Current finish condition due to existing slab depth.

**Deemed:** Incomplete works regarding slab edge finish to take proposed finish.

**Recommendation:** No Action

- Minor preparation work to proud slurry to corners by Tiler.
- Simple butt joint as per subject is 'one' of the typical industry practice of this context. *Refer AS 2870 Residential Slabs and Footings*. No movement joint is recommended as this may impact on any 'physical' termite barrier required once slab and slab faces are tiled. Slab edge was always going to be face treated before tile installation, and with regard to retaining physical termite barrier.

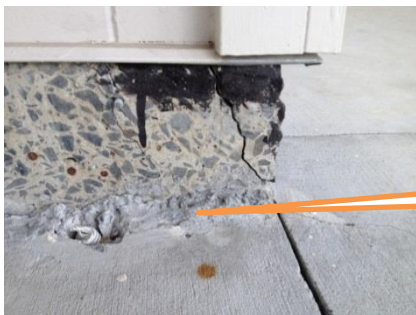
Minor preparation work to take tiling.

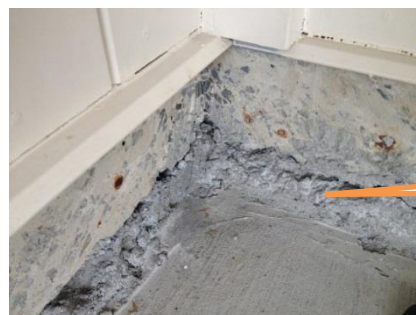
Minor preparation work to take tiling.

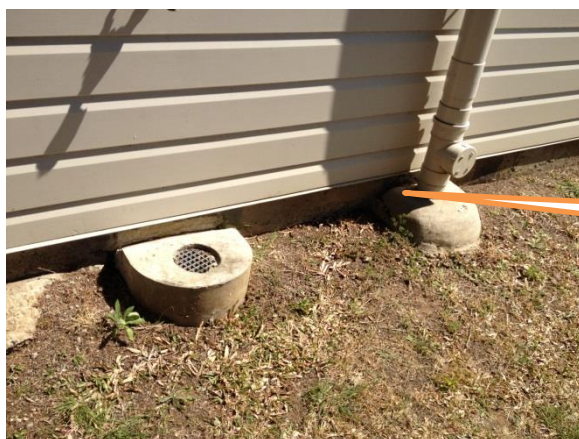
**Observation:** Modified concrete surrounds allows adequate visual barrier to slab edge. Considered that the current visual barrier dimension is adequate and permanent and therefore complies with the intent.

50mm exposed slab edge to both fixtures.

**Deemed:** Has been Rectified.

**Recommendation:** No Action

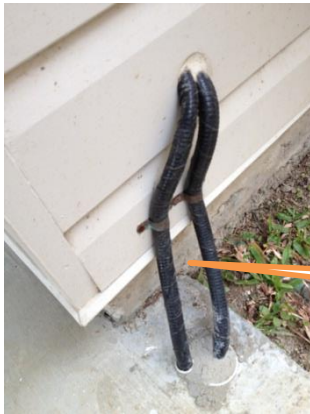
**Observation:** Exposed wiring from slab into wall subject to possible damage.

Secured and protected.

**Deemed:** Has been rectified.

**Recommendation:** No Action,

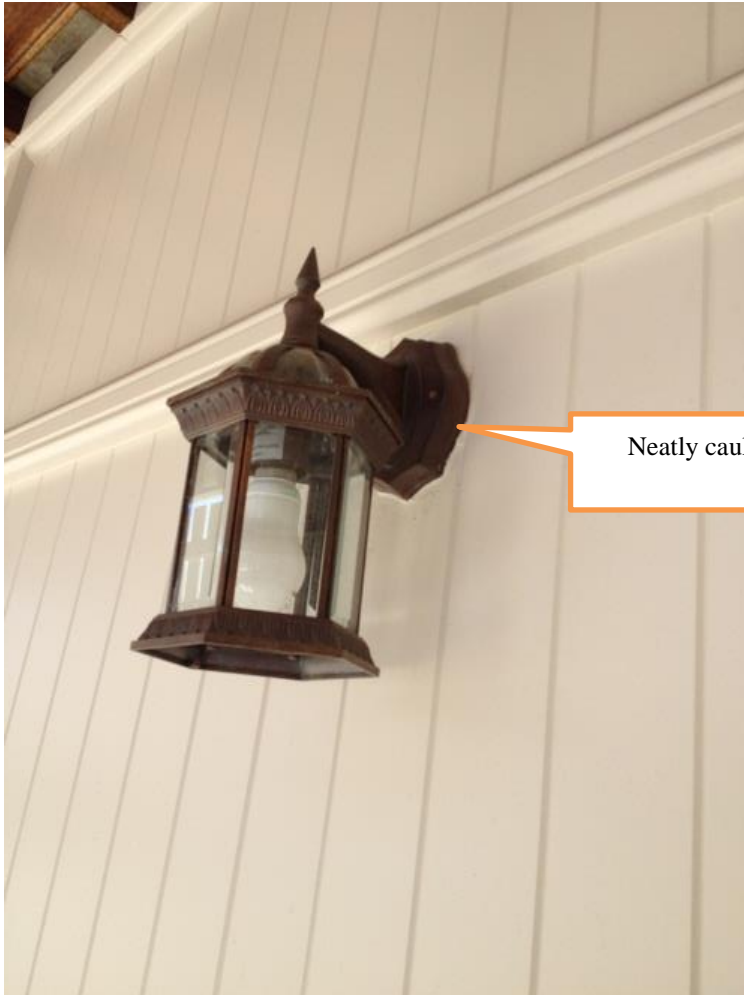
**Observation:** 8 external light fittings have been fitted without mounting blocks to substrate. Fitting gaps has caused caulking to be required to fill gaps in VJ boards in parts and around base profile.

**Deemed:** No Defect to Sample.

**Recommendation:** Review all fittings if required.

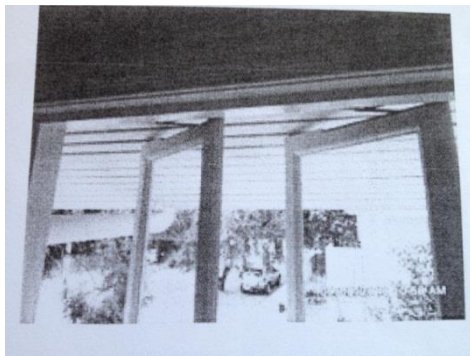
Item a. Casement windows bind on soffit lining due to height of installation into 'existing opening'. STANDARDS & TOLERANCES 2007 *'If windows bind or jam as a result of the builders work. All clearances shall be sufficient to enable installation to be plumb, level and operate as intended by the manufacturer'*. Recommend referral to subsequent written correspondence with builder & owner regarding acceptance of binding noting that the Owner was known to have acceptance to the effect *'that there was adequate opening ability in the existing opening'*;

Item b. Light warping to casements in part not enabling casement to fully seal on all sides. This appears to be a manufactures tolerance, noting the windows are constructed of materials subject to environmental variations.

- a. Class 2 Defect- However the photo indicates adequate 'operability'.
- b. No defect, as it is considered within acceptable tolerances.

- a. No action. Consider install shallow profile soffit battens to area.
- b. No action. Alternatively Owner to remove existing seals or install softer compressible seals.

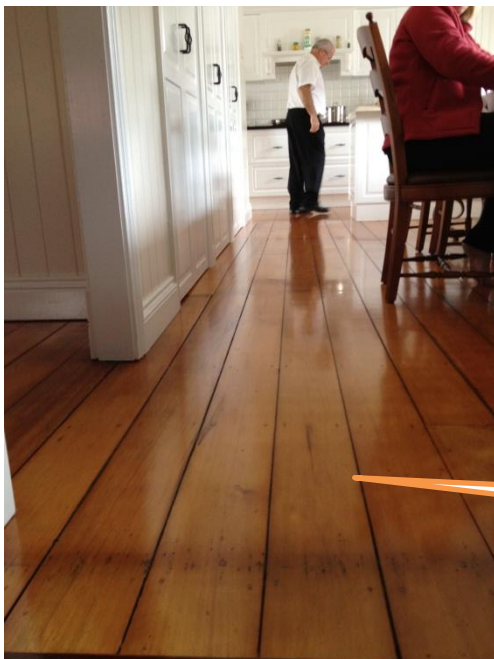
**Observation:** Gaps in 2 floor boards. Gap to exposed timber flooring is defective if it has a gap of more than 2mm between adjacent boards that extend for more than 1m. However it does continue to match the existing floor gaps in the adjacent Dining room supporting Builders statement. Note that modern flooring does not generally suffer shrinkage as would appear to be the case in this instance further supporting Builder.

Extensive gaps to adjacent  
Dining Room floor

**Deemed:** Plausible 'Purpose made' Class 2 appearance defect.

**Recommendation:** Confirm correspondence between Client/Builder/Floorer to continue gaps. Fill gap with matching strip as method of any rectification.
