An Independent Opinion

Shelter Architects & Planners Pty Ltd

INSPECTION DETAILS, LIMITATIONS & OBSERVATIONS

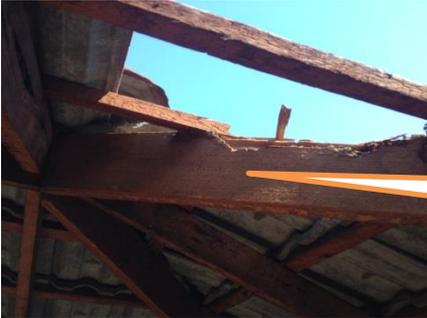
The extent of the noted damage appears isolated to the full length of the hardwood timber hip rafter, with minor damage to structural and ancillary timbers members abutting to hip rafter. Areas of hip rafter damage vary from 20% removal of structural timber through to 50% and beyond, leaving the hip rafter in an inadequate structural condition. It appears roof framing and support members offer structural support to the damaged member.

Photo1: Identified damaged area of hip rafter approaching full extent of member up to roof ridge.

The extent of damage is considered to be concentrated and isolated, generally only requiring the full replacement of the north-eastern hip rafter as the major structural member. This will include portions of ancillary items, such as roof batten replacement to the subject area where broken, inadequate or trimming is required to gain access for removal & installation. It may also require to include the installation of alternative fixing mechanisms to abutting members e.g. jack rafters, where adequate surface mating material has been removed. These fixings may include to likes of framing anchors, strapping etc to re-instate nominal hold down points, before closing roof with the re-instatement of matching tiles and pointing with the inclusions of items considered necessary to 'make good' the area, and removal of builders rubble.

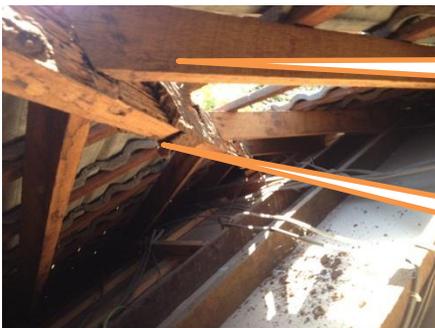
Jack rafters offering support to damaged member.

Photo2: Generally damaged timbers throughout extent of member.

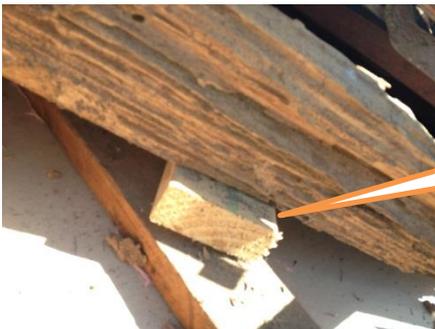
Note: Additional ancillary timber members have been installed where the lower hip lands on the wall framing top-plate, suggesting the area had previously suffered isolated termite infestation - given the timber plantings are modern softwood materials type, not those materials available at time of original construction. Refer Photo 3.

Photo3: Hip rafter adjacent top plate has been severed by previous infestation. Note pine chock to support where it doesn't adequately land on top plate.

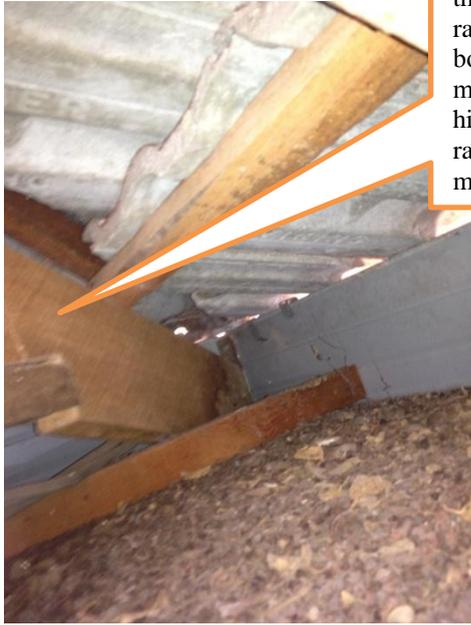
Photo 4: No visual evidence of infestation in the eaves soffit cavity. Note that the hip rafter tail is currently severed from main body of the member where it is 'birds mouthed' over top plate. The full extent of hip rafter to be replaced incorporating hip rafter tail to be re-fixed to new portion of member.

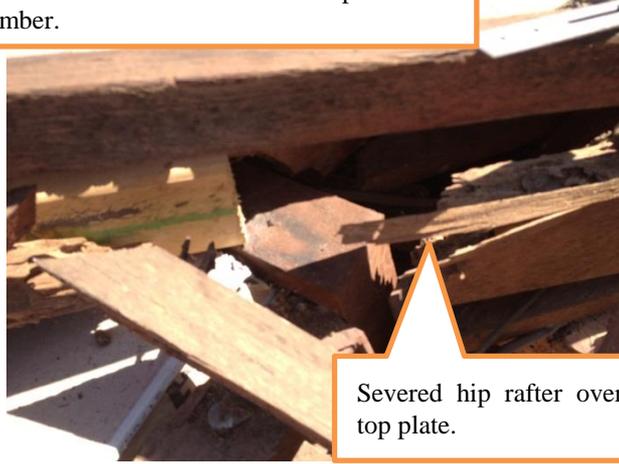
Severed hip rafter over top plate.

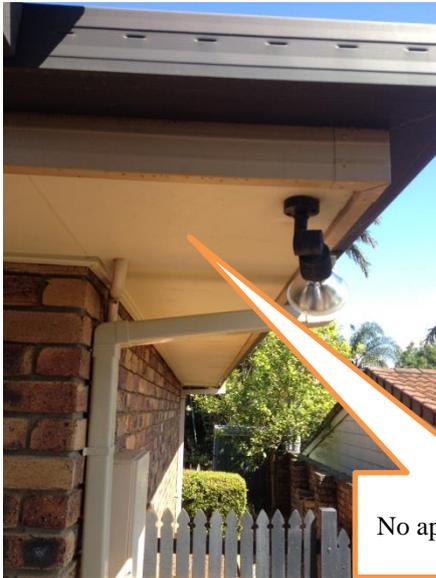
Photo 5

No apparent deflection.

The soffit lining and framing did not appear to have suffered any noticeable deflection from inadequate support, however further determination as to adequate support, and fixings will be determined at time of full opening up reconstruction of area. Refer photo 5 & 6

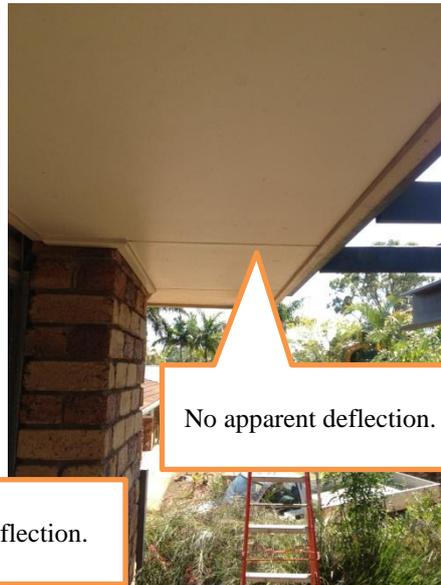
Photo 6

No apparent deflection.
