Premium Property

— REPORT —

45 SAMPLE STREET BRACKEN RIDGE

INSPECTION SUMMARY

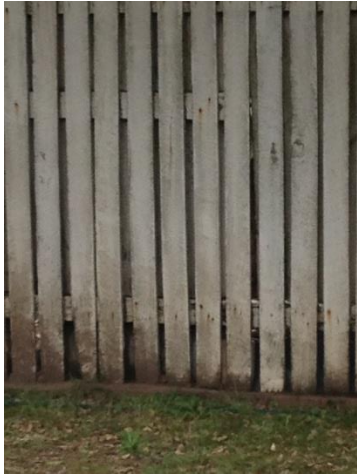
SITE				
Fencing	X	1, Areas of spot rot to front timber infill fencing; 2. heavy aging and rot to lhs timber fencing (Photo 1 recommend trim bases, fix posts bases to steel stirrups & repaint) and 3, moderate cracking across rear block work fencing should may last medium term before demolition. (Photo 2 note the cracking has returned since last repaint suggesting unstable conditions	AR	1 / 2
Retaining walls	n/a			
Driveway	X	Moderate cracking and lifting to concrete slab driveway and garage slab- Stable for medium term.	NAR	3
Paving/Decking	X	Lift movement to paving to rear and typical concrete cracking.	NAR	
Surface drainage	X	Heavy areas of over land flow falling to entire building perimeter - Photo 4 is lhs of building with heavy rutting of surface water causing high moisture content/rising damp contributing to heavy spot fretting to brickwork in areas; Photo 5 depicts ponding to rear of building. All has led to causing differential settlement i.e. the rear extension appears to have sunk; and cracking brickwork to lhs. Refer notes on Superstructure All surface water requires capturing and diverting away from building perimeter.	AR	4 / 5

Photo 1 – Rot to batten bases and posts

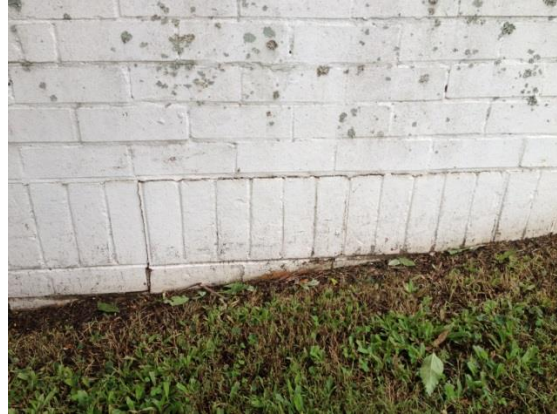
Photo 2 – Returned cracking to brick base

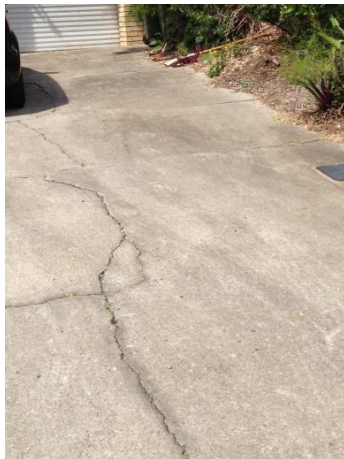
Garage/Carport	X	1, Cracking slab base (as noted Photo 3), 2, aging and deteriorating finishes generally and 3, (Photo 6) missing gutter and 10% loose roof sheeting requiring re-fixing).	AR	6
Isolated structures	X	Cubby house structure is not tied down to ground and may move under heavy wind.	NAR	
Water Tanks	n/a			
Pool Fence	X	Recommend carrying out repairs to gate (not self-closing at present) and review to comply with current pool fence compliance requirements.	AR

Photo 3 – Moderate movement cacking

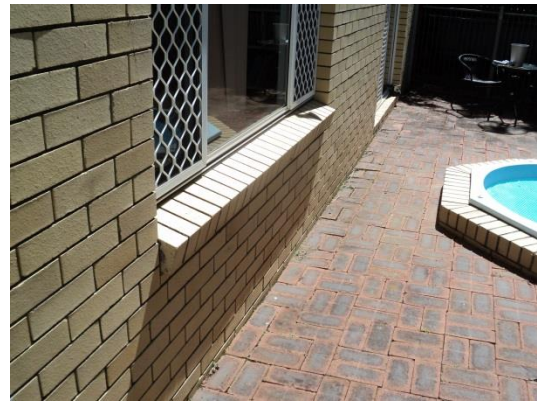
Photo 4 – Moss/staining to base of wall.

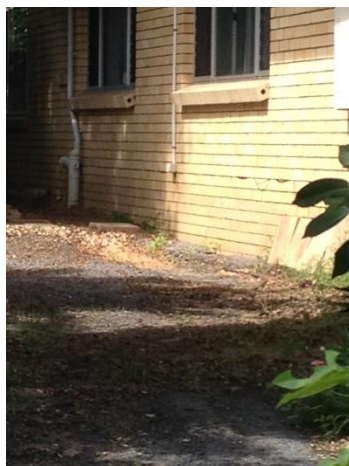
Photo 5 – Surface water scouring.

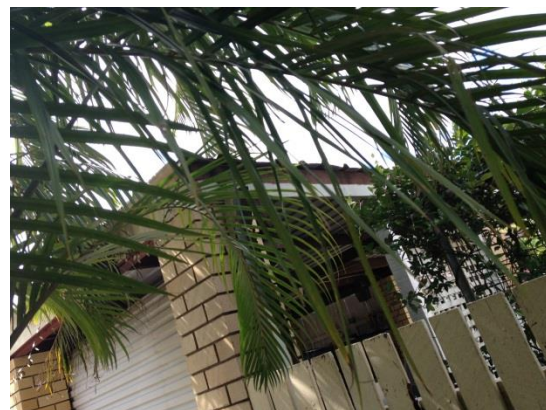
Photo 6 – General finish deterioration

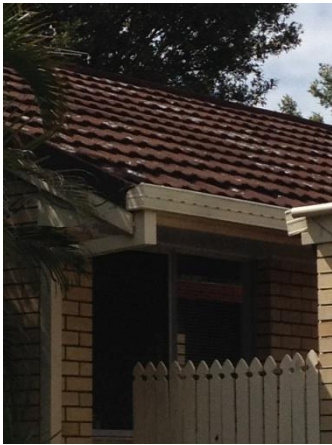
ROOF				
Roof covering	X	Extensive area of finish deterioration and damage from foot traffic to soft metal tiles- Generally cosmetic concern only.	NAR	7
Flashing & Valleys	X	Heavy ponding and repairs carried out to chimney flashing with noticeable spot leaking to interior of roof void and salting to brick face over fireplace internally-Periodically review flashing	AR	8 / 9
Penetrations	AOK			
Skylights	AOK			
Solar panels	n/a			
Solar HWS	n/a			
Vents	AOK			
Ancillary fittings	AOK			
Eaves & soffit	X	Typical light weathering to painted and timber finishes.	AR	
Gutters/Downpipe	X	1, Variable debris, rusting and leaks generally- Clean and treat. 2, downpipe and field gully to front rhs appears to have blocked at ground level and is rising out the grate causing ponding to building perimeter	AR	10
Chimney	X	Refer note on flashings	AR

Photo 7 Pebble finish lifting and foot traffic damage

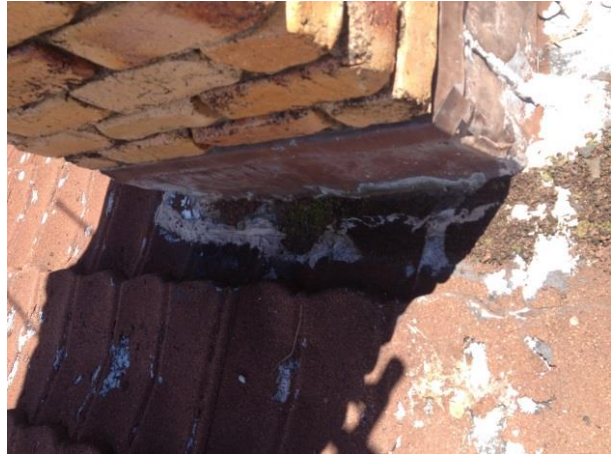
Photo 8- Re-patching to chimney flashing

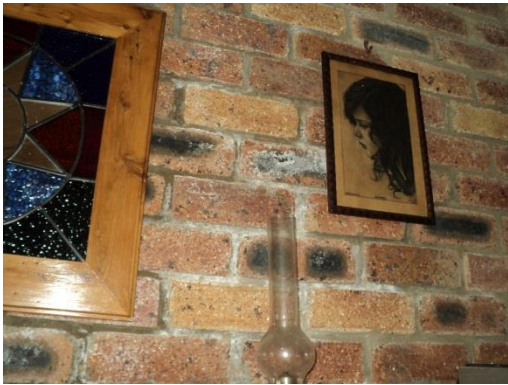
Photo 9- Moisture effervescence to bricks.

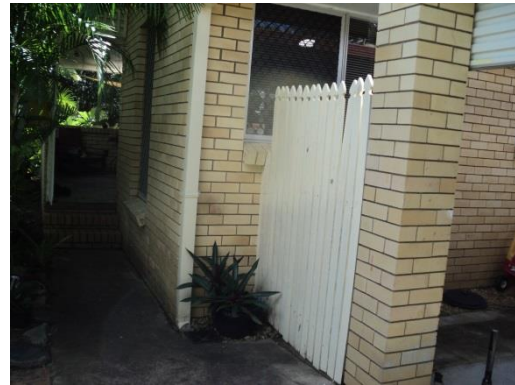
Photo 10- Gutter water ponds to front entry.

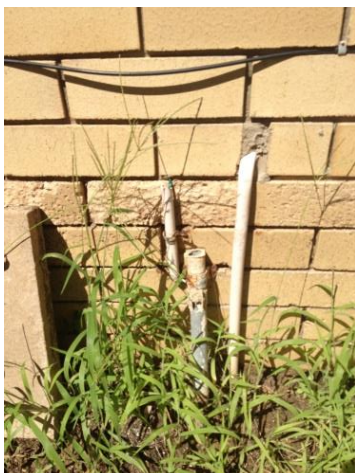
SUPER-STRUCTURE				
Wall Structure	XX	1. Rear extension has suffered differential settlement as noted in cracking brickwork (Photo 10) and level changes to bricks mortar lines and roof not depicted in photos; 2. Heavy fretting -Photo 11 typical to 10% of brickwork overall to lower level bricks and mortar. Fretting is due to high soil / brick moisture and salt content with the salt crystals inside the masonry expanding leading to the bricks and or mortar fretting. Minimise future cracking and fretting by installing effective drainage as a minimum.	AR	11 / 12
Cladding/Finish	X	Typical light weathering to painted and timber finishes generally- (refer photo 7)	AR	
Veranda Floor/Frame	AOK		NAR

Photo 11- Spot fretting of brickwork

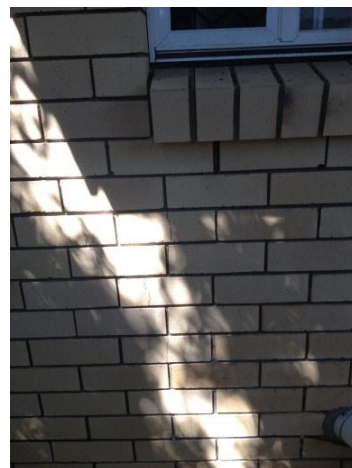
Photo 12- 'Opening' cracking brickwork due to settlement.

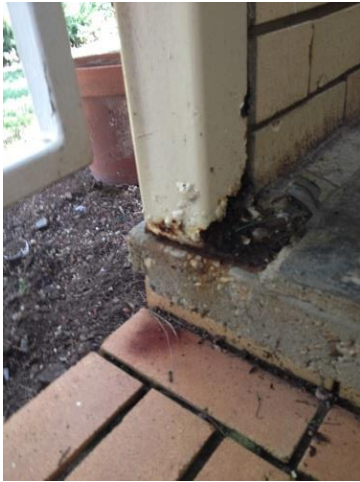
& Stairs				
Columns/Posts	X	Heavy rusting to base of Patio post	AR	13
Balustrades	X	Light hairline brick cracking to balustrade.	NAR	
Doors/frames	X	Typical light weathering to painted and timber finishes.	NAR	
Windows/frames	AOK			
Screens	AOK			
Other

Photo 13- Heavy rusting at base

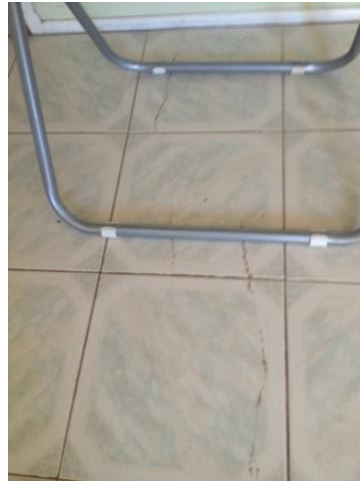
INTERIOR				
Floor structure	X	Notes extensive drummy tiles and variable tile cracking to areas including old/new slab joints- The photo depicts cracking to Bed1 area (new area) appears due to slab movement/heaving.	AR	14
Floor finish	X	Refer above		
Staircase	n/a			
Wall structure/finish	XX	Apart from extensive spot 'aging' damage to walls and ceiling innings cornices due to structural movement over time, there is noticeable termite infestation to the Laundry/Linen area and beyond. It has reached to roof framing. Areas require progressive invasive inspection to determine extent of infestation (which may be localised to Laundry/Linen & Bathroom) and to scope full structural and lining damage and rectification costs. Also other area of spot damage with undetermined cause. Refer Pest Report.	AR	15/16
Ceiling finish	XX	Noted areas of framing movement causing cornice defects. Considered due to slab heaving from excessive ground moisture levels.	AR	17/18

Photo 14 – Multiple split tiles due to slab cracking

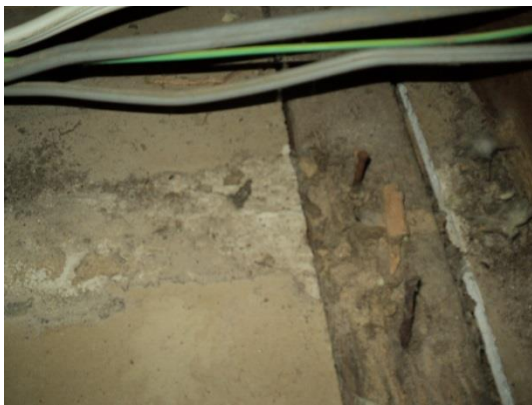
Photo 15- Fully destroyed ceiling battens

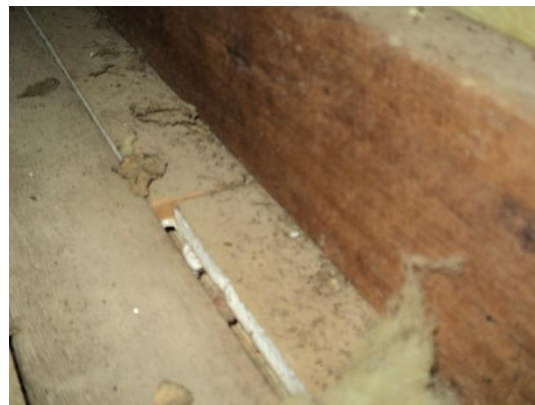
Photo 16- Further 'workings' evidence

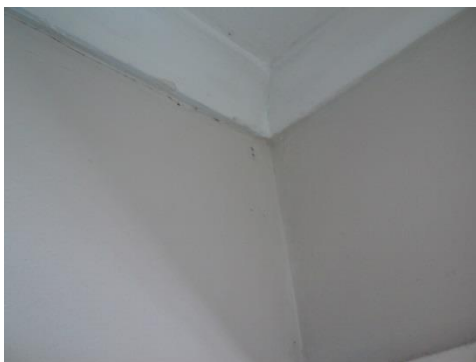
Photo 17 – Typical 'tearing' of joints due to slab and framing movement.

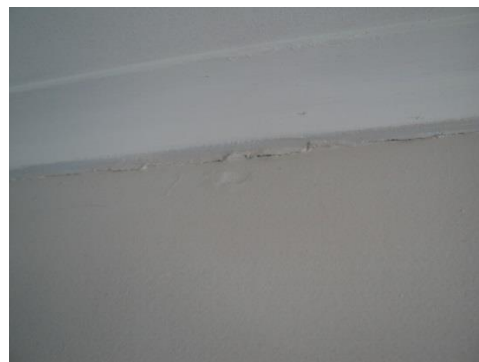
Photo 18– Typical 'tearing' of joints due to slab and framing movement.
